Immediate Microleakage in Direct and Indirect Restorative Procedures

J Nunes da Cruz², AC Azul^{1,2}, P Moura^{1,2}, M Polido^{1,2}

¹Centro de Investigação Interdisciplinar Egas Moniz, CiiEM, ²Instituto Superior de Ciências da Saúde Egas Moniz, ISCSEM, Caparica, Portugal.

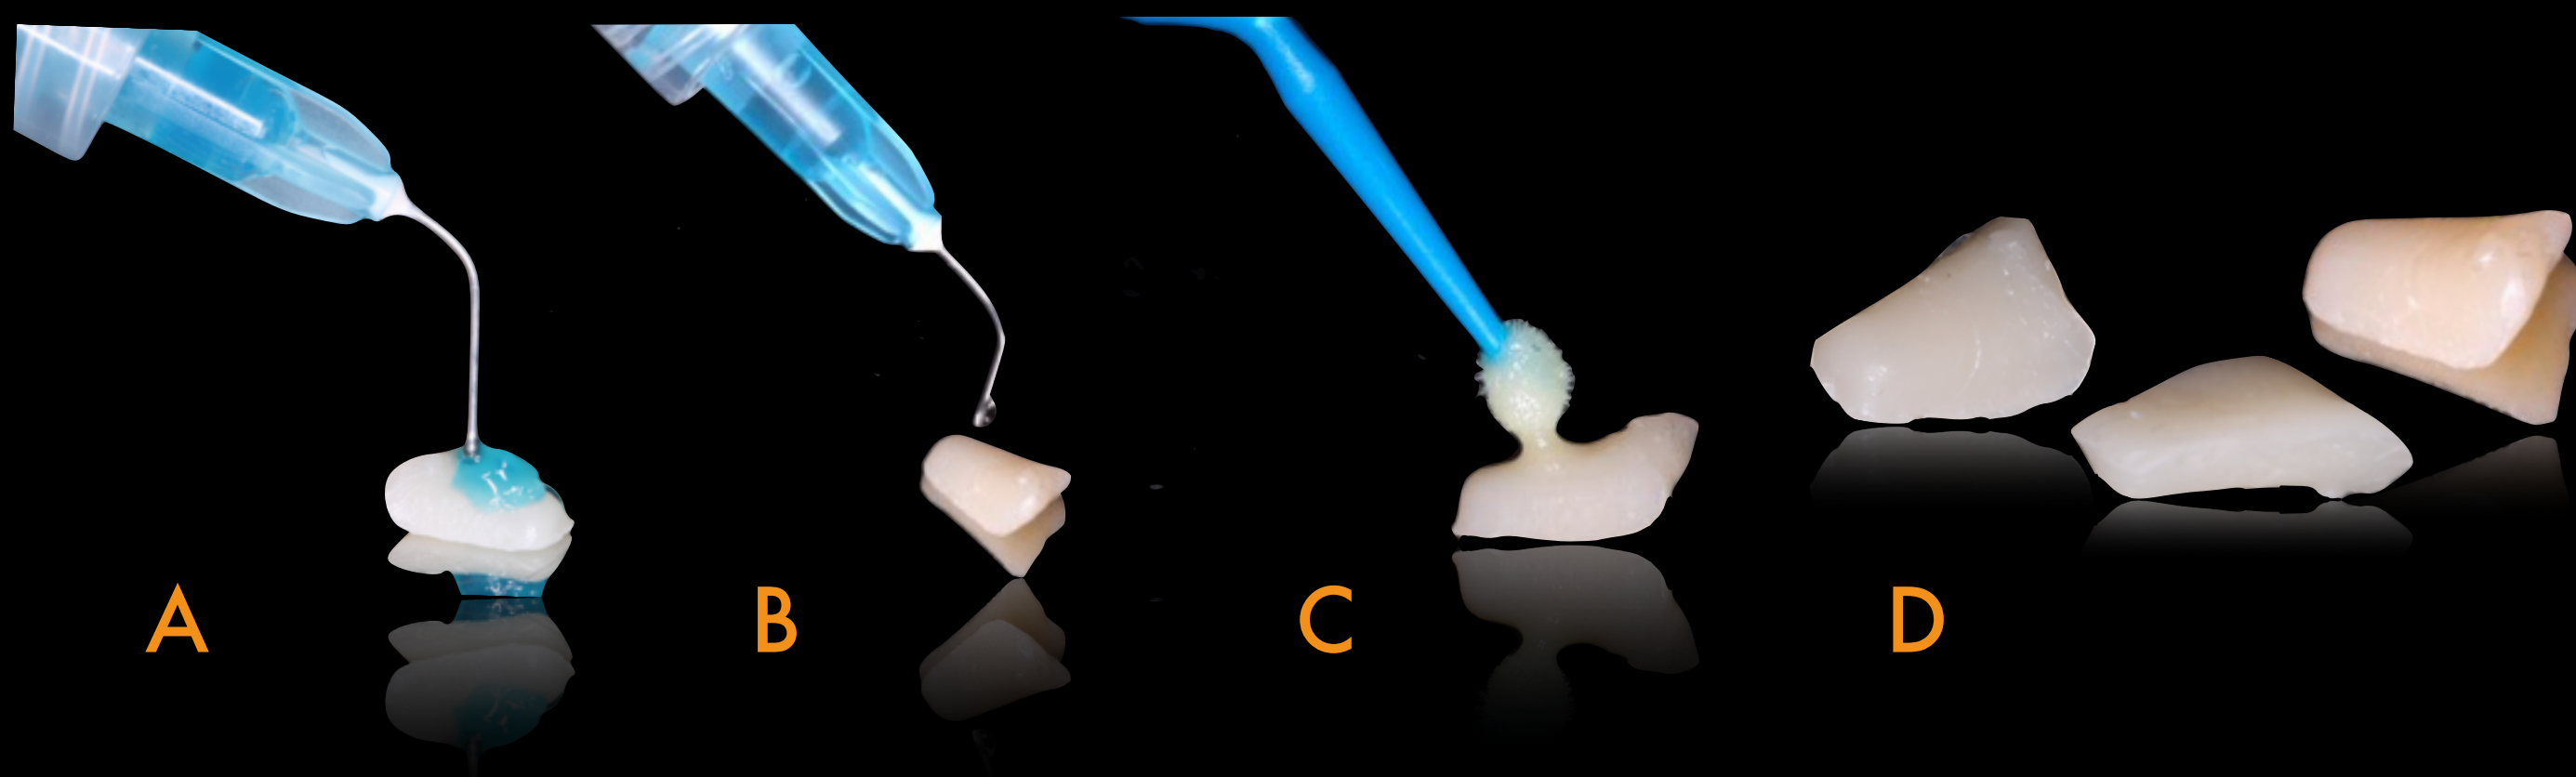
Figure 1: A - Inlay surface etching; B - Silane application on inlay surface; C - Optibond FL adhesive application on inlay surface; D - Composite inlays

Inlay Adhesion Protocol			Indirect Restorative Protocols		Direct Restorative Protocols	
Inlay Prep: Sand blasting (10 s) Orthophosphoric acid 37,5%, (1min) (Fig. 1-A) Ultrasonic cleaning (4 min) Silane coupling agent (Fig 1-B) Optibond™FL (Fig 1-C)			Group C: Optibond™FL adhesive protocol Grandio™ SO Inlay (Fig 1-D) 55° heated Z100™ composite Light curing (40s/side) Gliceryn gel cover Light curing	Group D: Optibond™FL adhesive protocol Grandio™ SO Inlay (Fig 1-D) Bifix™ QM resin cement Light curing (40s/side) Gliceryn gel cover Light curing	Group A: Optibond™FL adhesive protocol 3M Filtek Z250™ 2mm-increment direct placement	Group B: Optibond™FL adhesive protocol VOCO X-Tra Fil™ 4mm Bulk-Fill direct placement
Cavity Prep: Sand blasting (10 s) Orthophosphoric acid (30 s) Drying Optibond™FL without curing						
IDS Protocol²: Immediately after cavity prep: Optibond™FL, light cured Gliceryn gel application Adicional curing (10s)

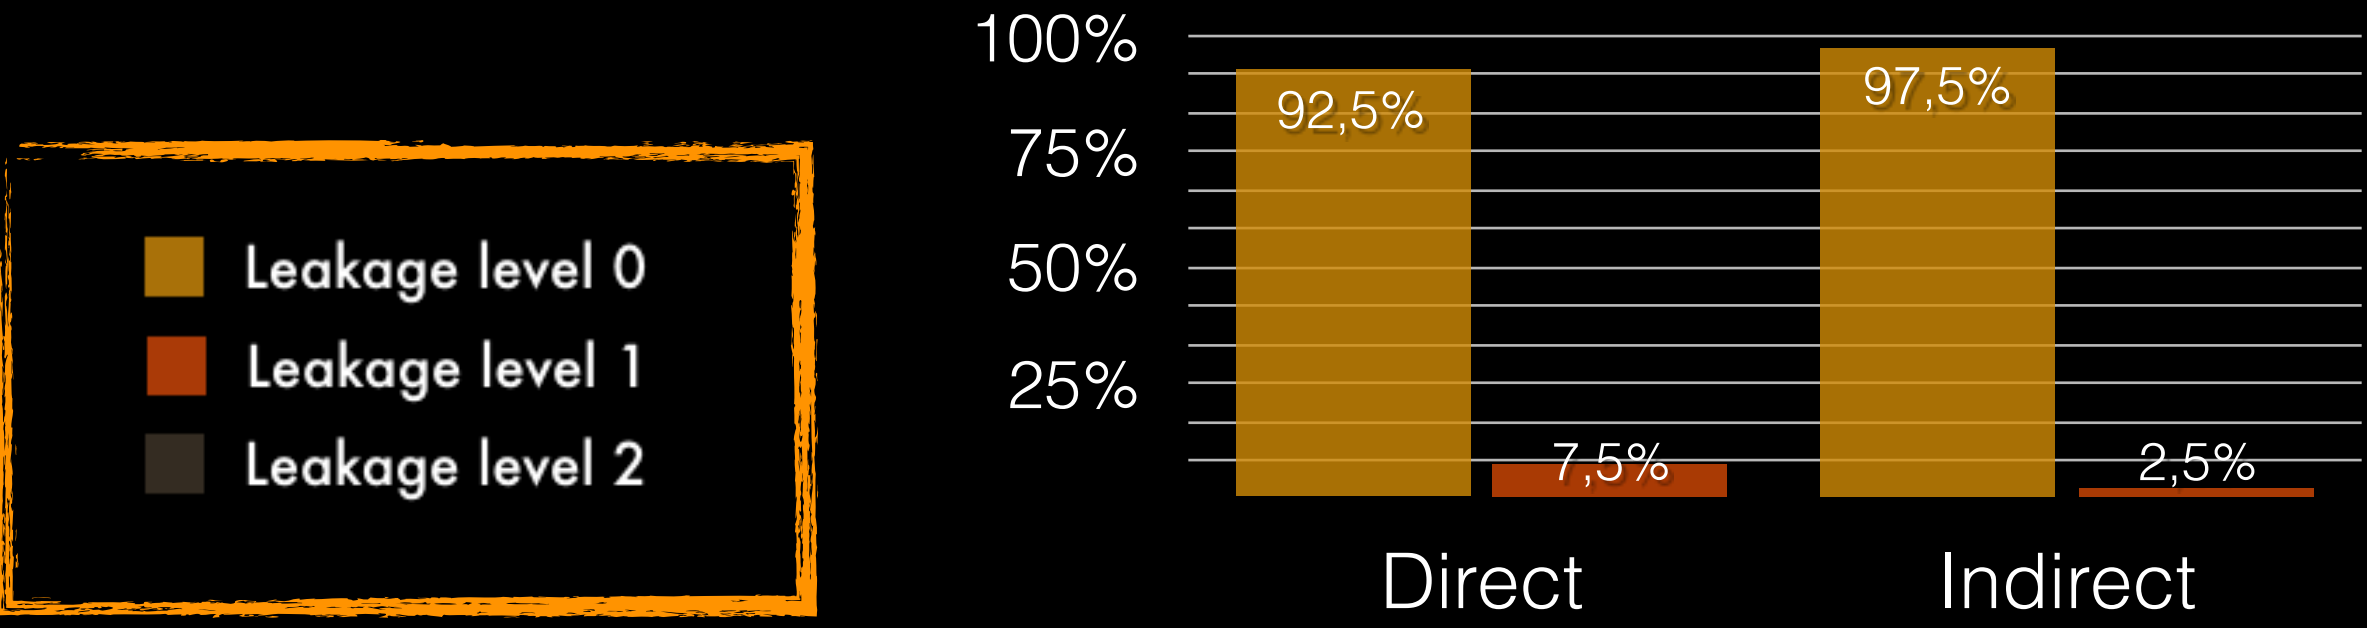
Figure 2: Leakage percentage in direct and indirect procedures in enamel margins

Results show no statistical differences amongst leakage levels, whether in dentin or enamel margins or in direct or indirect restorative procedures. **DIRECT VS INDIRECT PROCEDURES** - There seems to be a tendency for less leakage in indirect procedures when compared to direct procedures in enamel margins (2,5% vs 7,5%, $p = .294$) (Figure 2). In dentin margins, similar results also reveal a tendency for less leakage in indirect procedures when compared to direct procedures (22,5% vs 35%) (Figure 3).

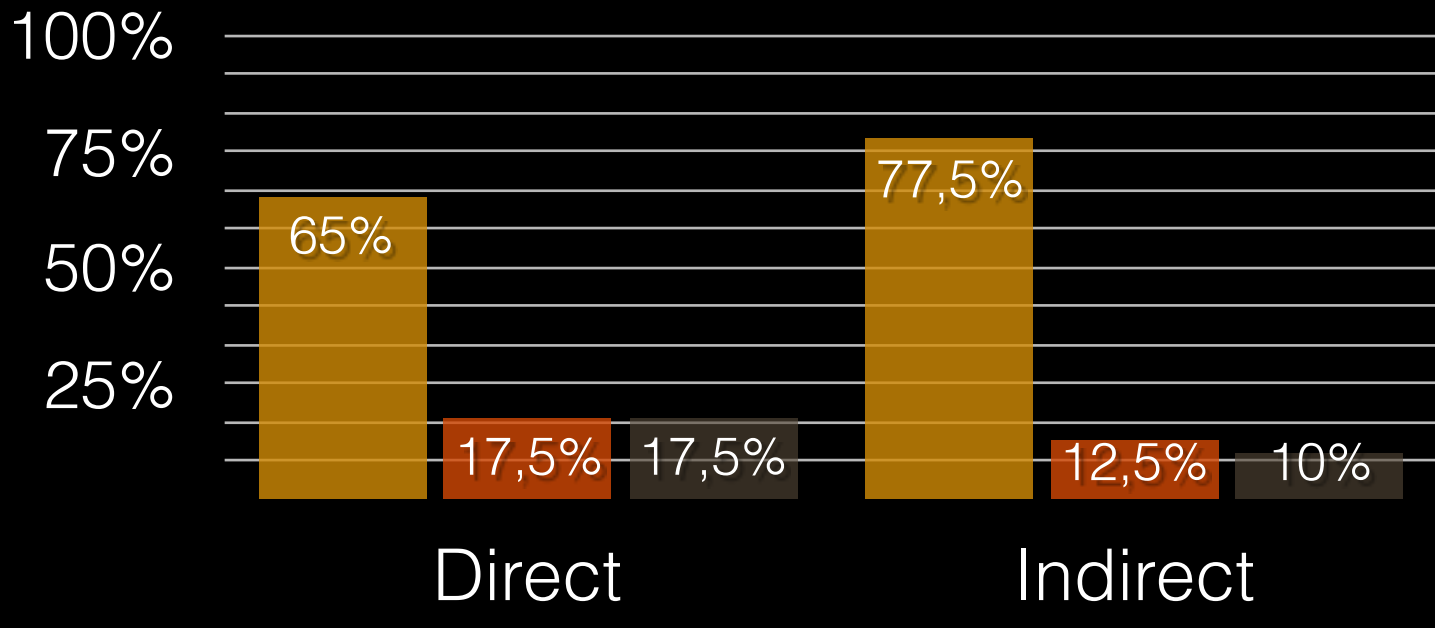
Figure 3: Leakage percentage in direct and indirect procedures in dentin margins

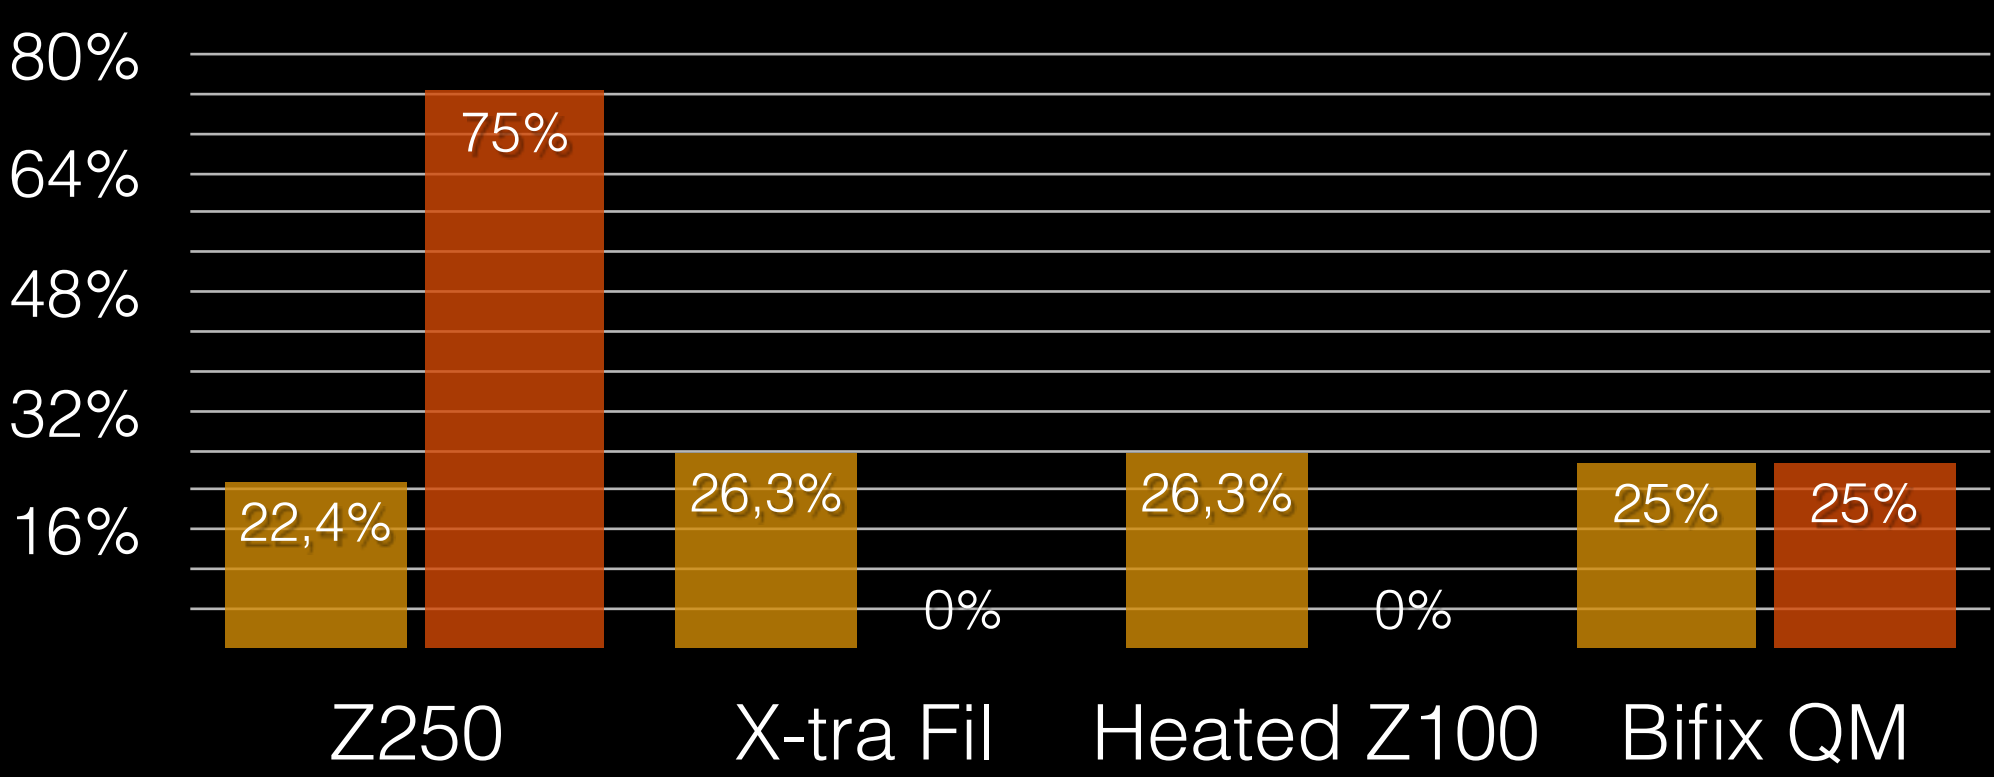
Figure 4: Leakage percentage in enamel margins

ENAMEL MARGINS - Enamel leakage results revealed a tendency for less leakage in Bulk Fill composite in the direct groups; composite luted inlays also seem to acquire better marginal adaptation (Fig. 4).

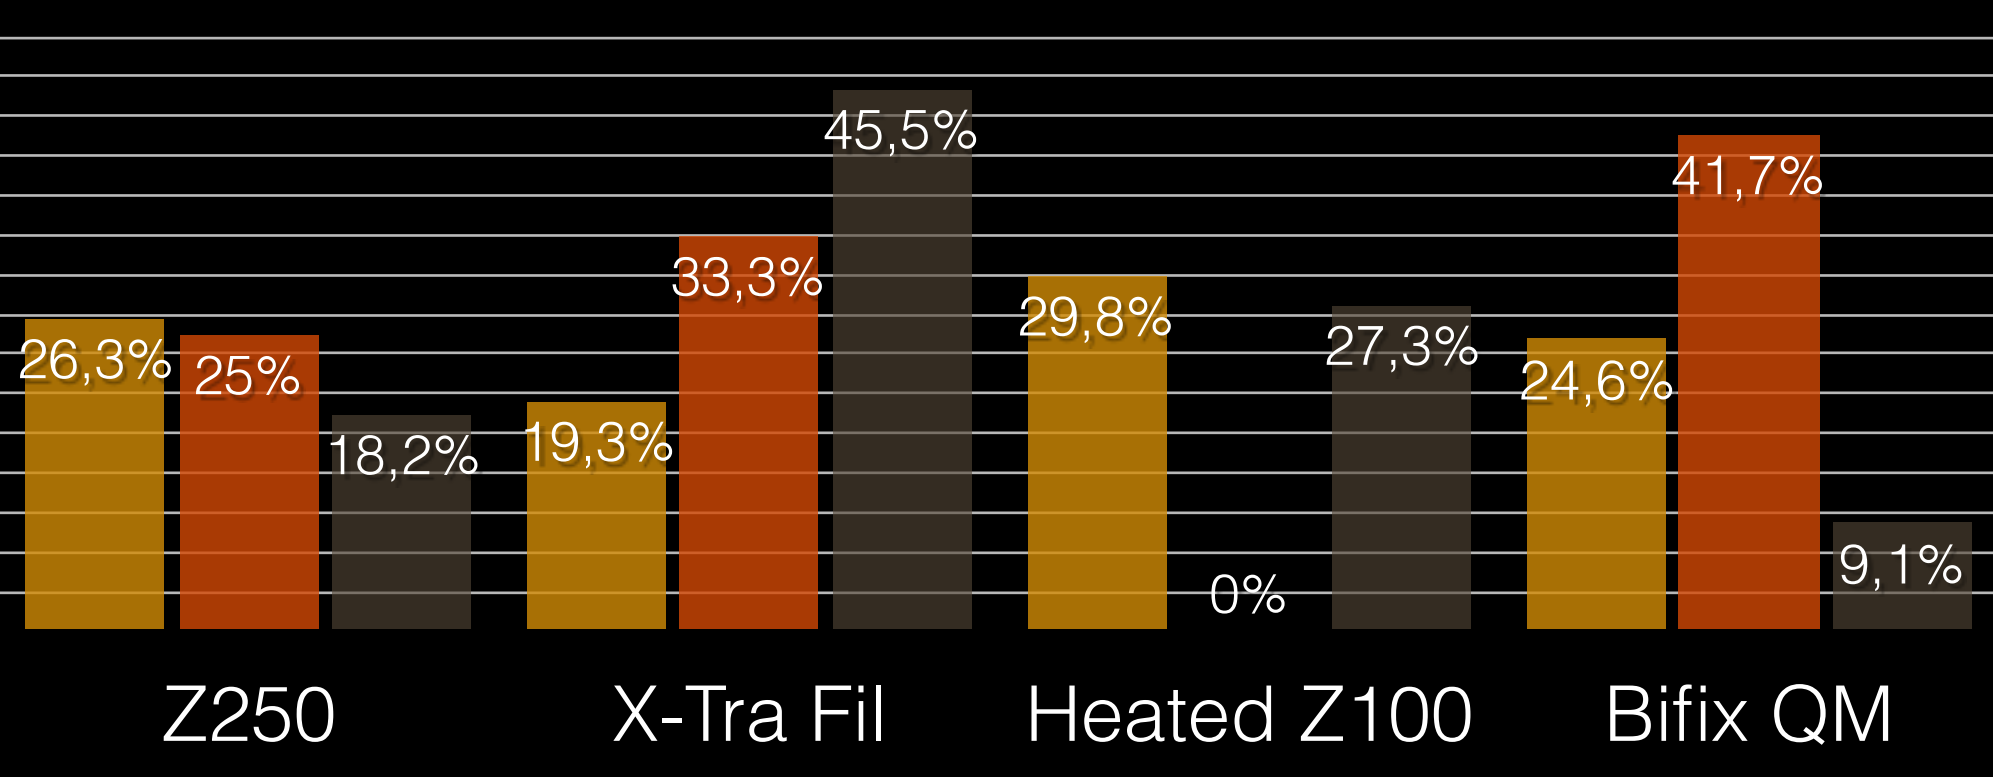
Figure 5: Leakage percentage in dentin margins

DENTIN MARGINS - Differently from enamel, dentin margins revealed a tendency for lower scoring in micro hybrid composite when compared to Bulk-Fill composite. The indirect techniques revealed less infiltrated samples when luted with 55° heated Z100 composite ($p=.166$)(Fig. 5).
